# Legacy herbicides in lake sediments are not preventing the growth of submersed aquatic plants in Lake Istokpoga

MARK V. HOYER, WILLIAM T. HALLER, JASON FERRELL, AND DEAN JONES\*

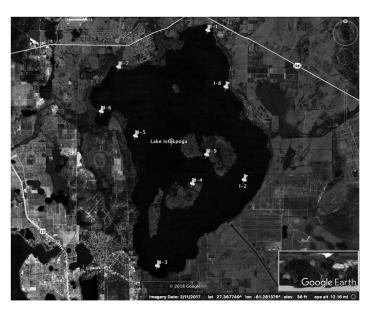
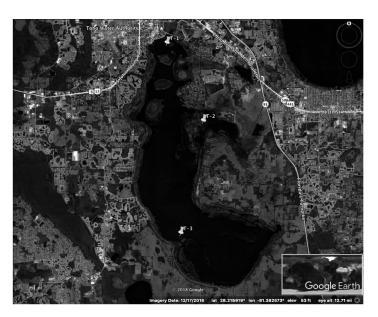
Figure 1. Google earth maps locating sediment sampling stations on Lake Istokpoga (a) and Lake Tohopekaliga (b). These lakes are of similar size and depth and located in central Florida about 200 km apart.

locations identified by the Lake Istokpoga Advisory Committee as areas that historically supported hydrilla in Istokpoga (Stations I-1, I-2, and I-3, Figure 1a). Sediments were also collected from three locations (May 13, 2019) in Lake Tohopekaliga, in which hydrilla was currently growing (stations T-1, T-2, and T-3; Figure 1b). Lake Tohopekaliga was chosen for comparison to Lake Istokpoga because of similarities between the two lakes. Lake Istokpoga is a large (surface area = 10,900 ha), shallow (mean depth = 1.6 m [5.25 ft.]), eutrophic (annual mean chlorophyll ranges from 12 to 62 µg L<sup>-1</sup>) lake, and hydrilla coverage from 1982 to 2017

On June 6, 2019, sediment samples were collected from all nine stations (Figure 1a) using a Petite Ponar sediment sampler. Samples were placed in 7.57-L (2-gal) plastic bags, sealed, and shipped on ice to Waters Agricultural Laboratories, Inc. (Vicksburg, MI, USA) for analyses of all herbicides, except diquat and endothall. An additional set of nine sediment samples were sent to North Coast Laboratories Ltd. (Arcata, CA, USA) laboratories for analyses of diquat. We could find no laboratories that would analyze sediments for endothall because of the low partition coefficient of endothall to hydrosoil (Reinert and Rodgers 1984) and the relatively short persistence in water (half-life = 4.01 d) (Reinert et al. 1985). All analyses were conducted using standard methods.
